State of Utah DEPARTMENT OF NATURAL RESOURCES Division of Oil, Gas & Mining

Inspection Report

Mine Name: Kimball Draw/San Rafael	Permit number: S0150075
Operator Name: U. S. Gypsum	Inspection Date: April 11, 2007

S0150075, San Rafael/Kimball Draw Quarry, U. S. Gypsum Inspection Dated: April 11, 2007;Report Dated: April 11, 2007

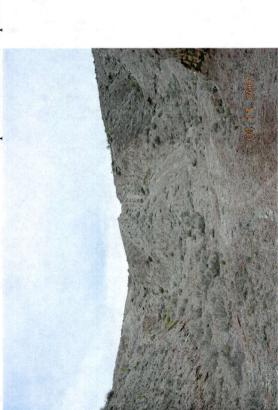
The site consists of a slot with a road beside it. Desirable perennial vegetation has become established on most of the disturbed area.

Photo 1. This shows essentially the entire site with the slot on the left and road on the right.

The Division and the BLM need to decide exactly what reclamation work should be done at this site. My recommendation is that grading be kept to a minimum to avoid disturbing the vegetation that has become established. The road needs to be closed, and it might be best to pull down the banks uphill from the road. There is one place in the trench that should be smoothed out (just to the left of center in Photo 1), but otherwise I think it would be best to leave the site as it is.

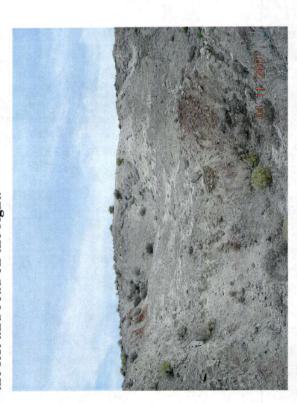
Photo 2. This is a small excavation to the side of the main trench.

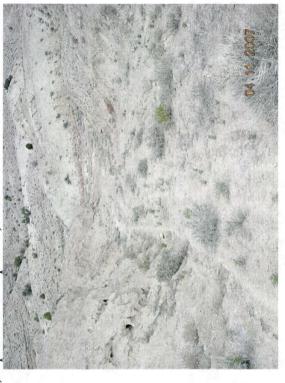
Photo 3. This and Photo 4 are views of the road. Note the perennial vegetation and the lack of weeds.

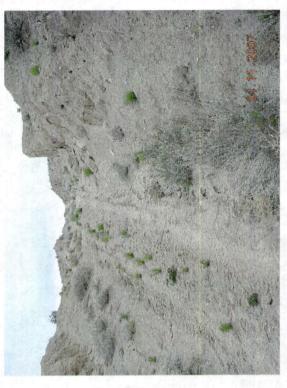
Photo 4. I believe it might be best to pull down the bank shown on the right side of this picture.
